Number: BA 06/11	Date: 01.06.11	Circulation:	5	KEY: 1 = Customer Service/ Technical Support 2 = Field Sales 3 = Inter-company 4 = External Distributors 5 = Special Circulation
Subject: Flite Cylinder Hose - CYL – FLITE – 10/15/SL - Update

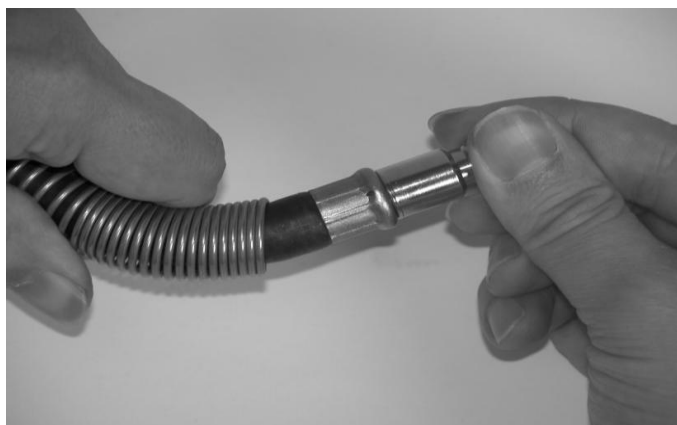
Photo 1 – Ferrule

Following notification from a customer of an incident involving a hose detachment on a Sabre Flite unit, Scott Safety would like to recommend the following inspection activities.

Customers can perform a basic inspection of the ferrules at each end of the hose, making sure that the hose can be seen through the inspection hole, the ferrule is not loose and when pressurised there is no leak. If you have any concerns having made these checks, please remove the set from operation and contact your Scott representative.
